# Manhole Inspection Summary

Manhole # S53E\_\_004MH

Insp Date: **4/25/08 1:56 PM**

**Location** Address: **11 s highland ave**

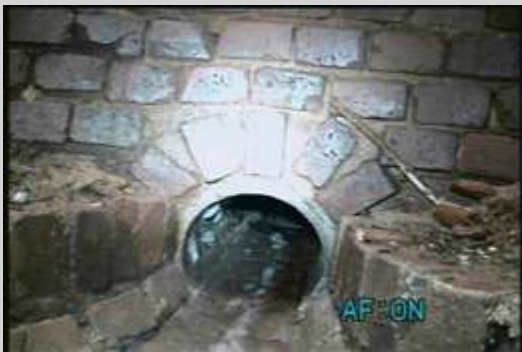
12 O'Clock Outflow

8 in. Circular Gravity Sewer  
Pipe Out @ 12 O'Clock

Invert Depth: **10.75** (ft.) Flow Characteristics: **Fast**

Deposits: ☒ None ☐ Mud ☐ Sludge ☐ Debris ☐ Grease

Infiltration: **None** Pipe Seal Cond: **Unknown**

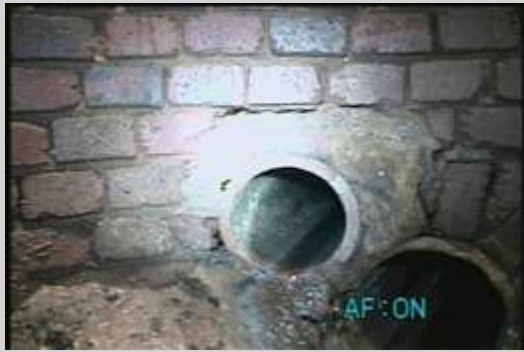
5 O'Clock Inflow

6 in. Circular Gravity Sewer

Pipe In @ 5 O'Clock

Invert Depth: **9.34** (ft.) Flow Characteristics: **Slow**

Deposits: ☒ None ☐ Mud ☐ Sludge ☐ Debris ☐ Grease

Connects To: **House connection / Service line**

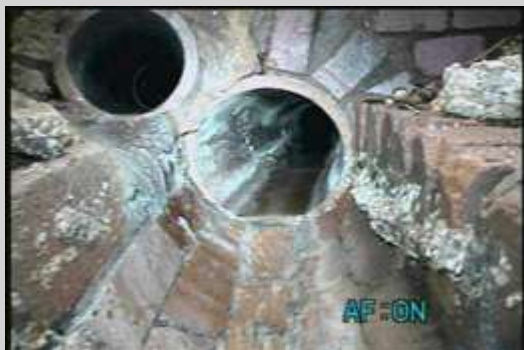
6 O'Clock Inflow

8 in. Circular Gravity Sewer

Pipe In @ 6 O'Clock

Invert Depth: **10.18** (ft.) Flow Characteristics: **Fast**

Deposits: ☒ None ☐ Mud ☐ Sludge ☐ Debris ☐ Grease

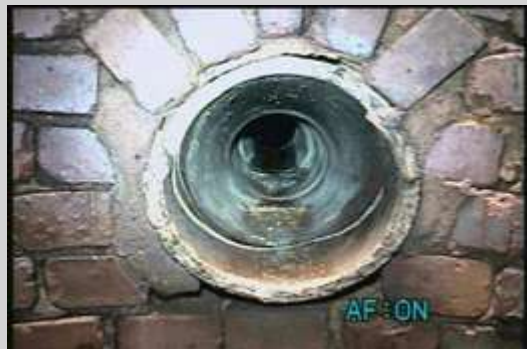
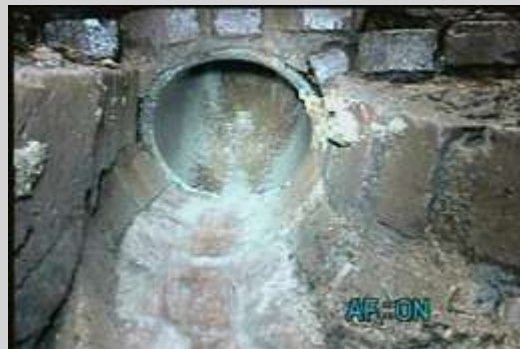
9 O'Clock Inflow

8 in. Circular Gravity Sewer

Pipe In @ 9 O'Clock

Drop In @ 9 O'Clock

Infiltration: **None** Pipe Seal Cond: **Unknown**

Drop Condition: **Open**
